Onsite Machining

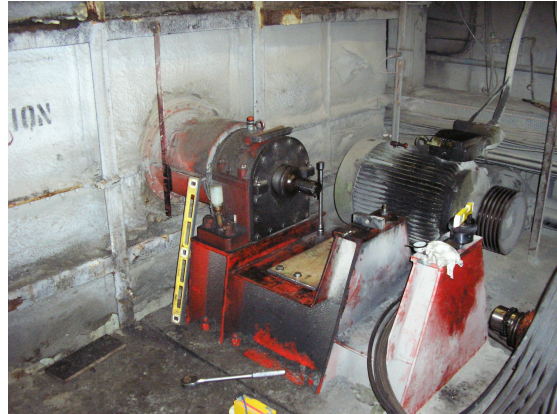
Above:
The site cleared ready for machining

After surveying the site in conjunction FirScot engineers the client built a frame around the end of a shaft. FirScot modified tooling and using an onsite compound slide machined the end of the shaft straight and true again. The process took less than eight hours. A new adaptor for the gearbox was machined overnight and the fan was rebuilt the following day

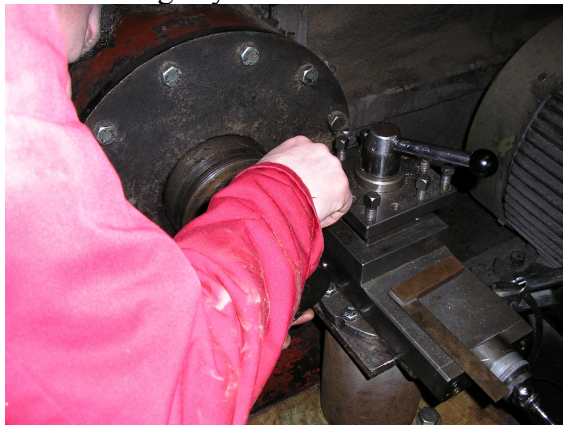
Left:
FirScot engineers machining the shaft
